In-flight Cold Injury from LOX System

Sqn Ldr S Damodaran^{*}, Wg Cdr GK Sapre^{**}, Wg Cdr MM Dogra[#]

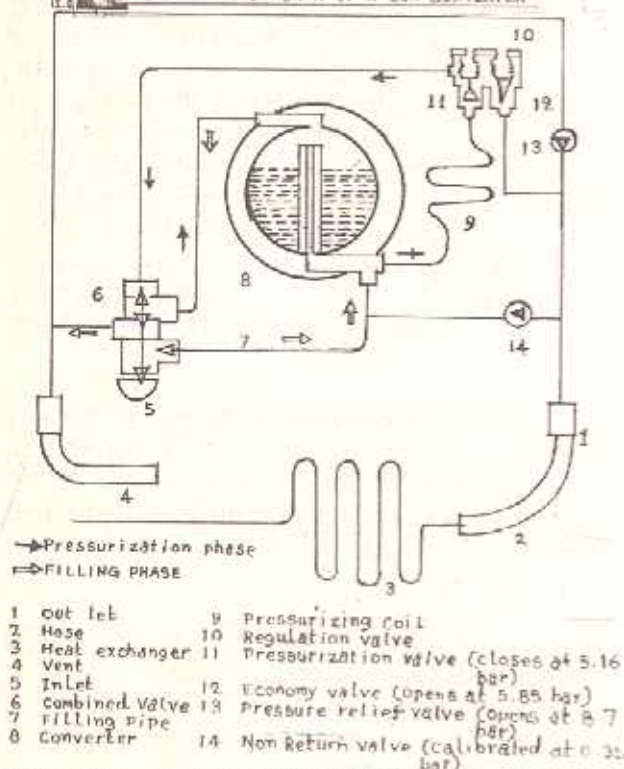
SCHEMATIC DIAGRAM OF A LOX CONVERTER

(b) **Shortage of warming up time** : The fall in the operating pressure did not occur because of the continuous high rate of demand during the 'clover' manoeuvre. Therefore the demand was met in the liquid state from the bottom of the container. The liquid vapourised and

directly entered the heat exchanger short circuiting the normal process of pressure build up (Fig :3). The heat exchanger could not handle this large flow of low temperature, low pressure gas. Therefore cold Oxygen entered the cockpit.
