## Case Report

### Ejection and shoulder injury

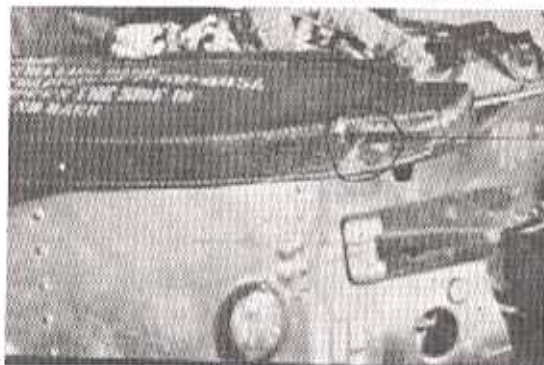
Photo 2 : Depression in the arm guard

- (ii) A depression in the padding of right armguard in its under surface near the tip.
  - (iii) A large hole in the nylon

The arm guards of the KM-1M ejection seat fitted in the aircraft are normally in retracted position. On initiating ejection they come down with a force. In the down position the inter arm guard distance is 55 cm. The inter deltoid distance (shoulder width) of the pilot was 45 cms. Static anthropometric consideration revealed a clearance of 5 cms on either side. This clearance is maintained when the ejection handle is pulled correctly with the palm facing upwards and arms close to the trunk (Fig 1-A). However, the clearance is compromised if the handle is pulled incorrectly with palm facing upwards and arms abducted at shoulder. Dynamic anthropometry showed that with the use of incorrect method the inter deltoid distance is increased by about 10 to 14 cms. In such a situation the inter deltoid distance increases to 55 to 59 cms in this case. This equals or exceeds the inter arm guard distance of 55 cms (Fig 1-B) resulting in fouling with the arm guard. This is corroborated by contact marks on the arm guard and overall (Photo-1 and 2). The fouling resulted in fracture of surgical neck of right humerus.

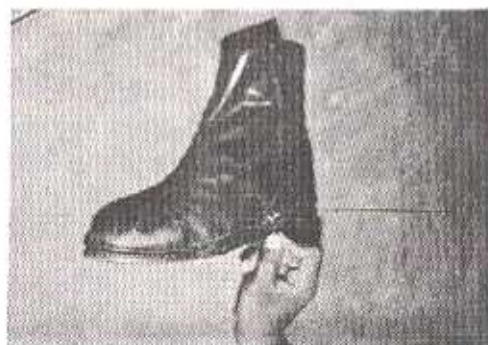
Photo 3 : Gap in the zip of flying boot

socks of right foot with burnt and rolled out edges.

- (iv) A gap in the zip of right flying boot.

Examination of the flying boots and socks showed a gap in the zip of the right boot and a burnt hole with rolled out edges in the right socks (Photo 3). The burnt hole may be due to the hot gases which entered the cockpit just before ejection. The temperature of the hot gases might have been sufficient to burn the nylon socks but were not hot enough or of less duration to cause any thermal injury to the pilot. The burnt area corresponded to the gap in the zip of right flying boot. This fact brings out the

checking serviceability of flying clothing as trivial as the zip of the boot.
